## Roof Condition Report

**9BSE-A - Administration Building**  
Intermountain Power Service Corporation  
850 West Brush Wellman Road  
Delta, Utah

June 2001

Brower & Associates  
Architects & Planners

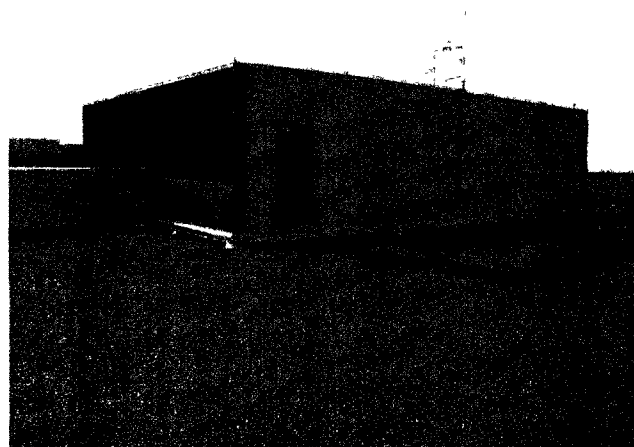
Photo No. 10

North parapet wall. Note the hole in the wall and the gap at the top of the counterflashing. The base flashing has been painted at all joints around the roof.

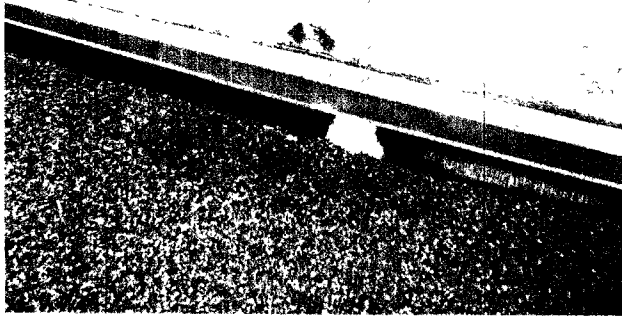
Photo No. 11

Northeast corner of the roof, looking east. Note the brace in the corner and the two holes below. The parapet is bare concrete.

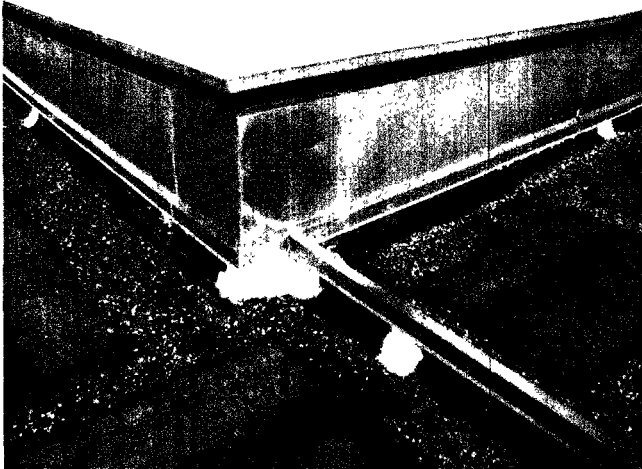
Photo No. 14

The southeast corner of the roof, looking to the southeast. No crickets are present to direct the water to the roof drains.

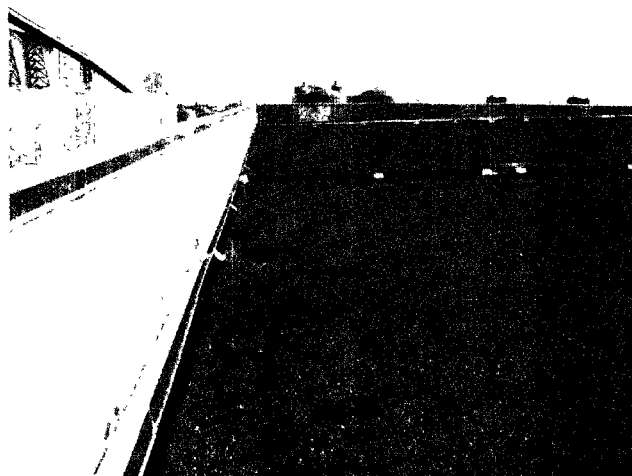
Photo No. 21

West parapet of the building, looking north. Note the blueberries in the lower center of the photo. No crickets have been installed to direct the water to the drains.

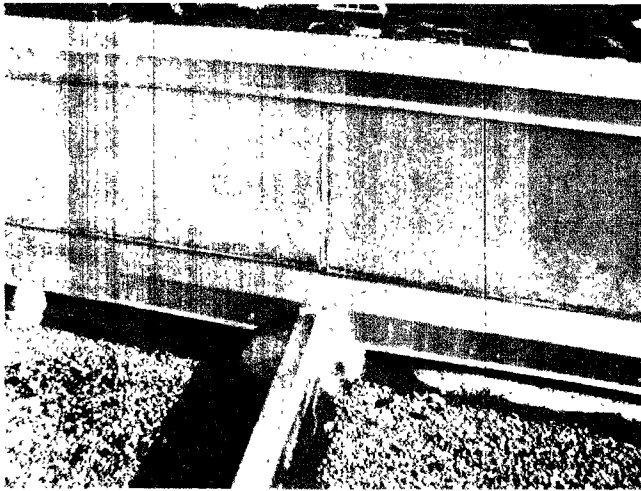
Photo No. 25

The joint of the expansion joint and the north parapet wall. The joint in the wall is separating.

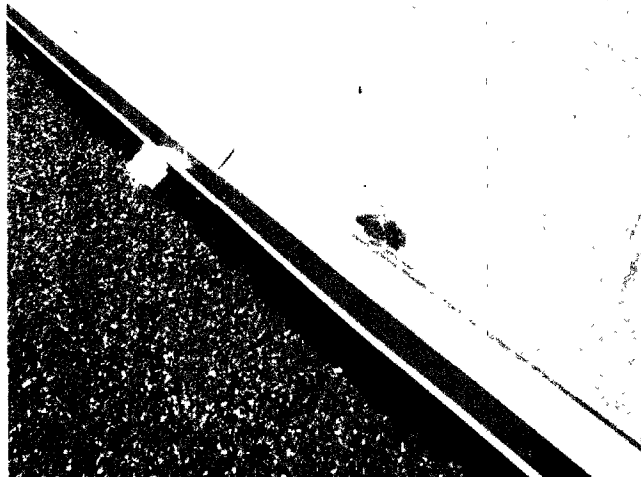
Photo No. 27

Gap in the counterflashing and a hole above the metal.

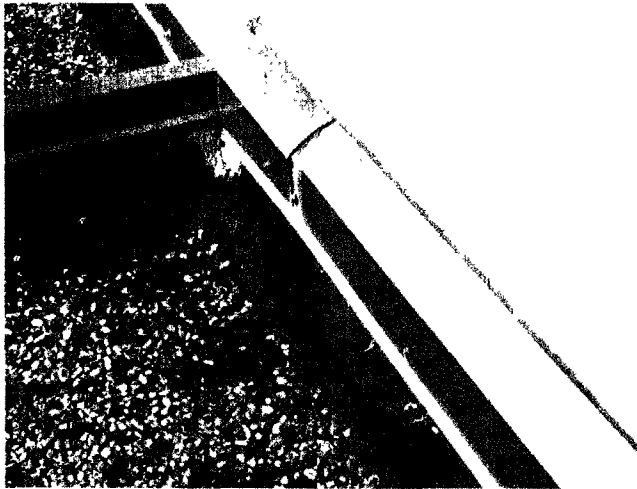
Photo No. 28

A gap in the counterflashing.

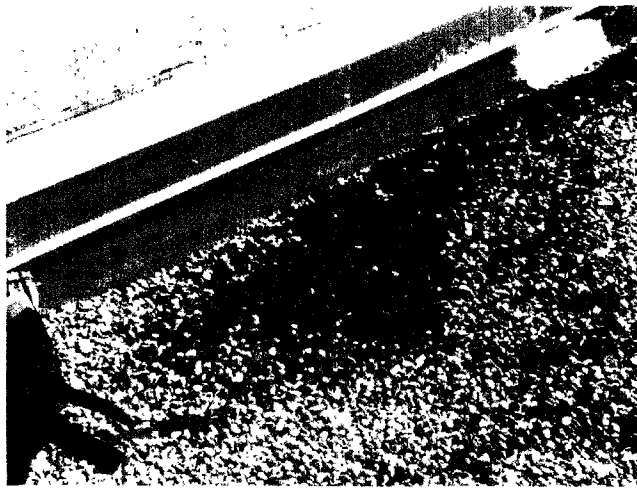
Photo No. 29

Extensive blueberries adjacent to the  
parapet wall.

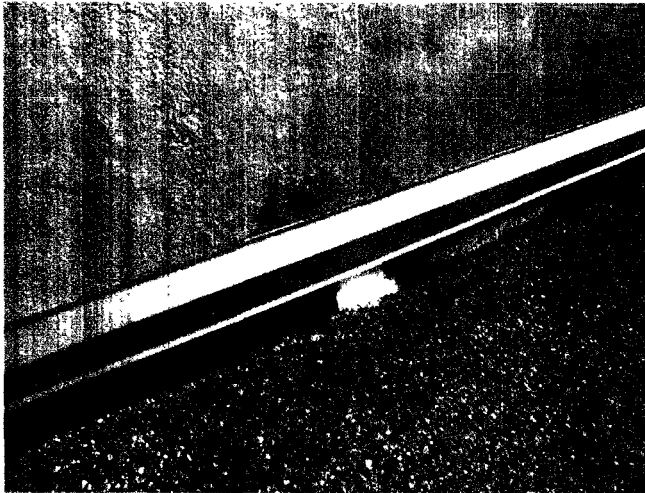
Photo No. 31

Holes in the wall above the metal counter-flashing.

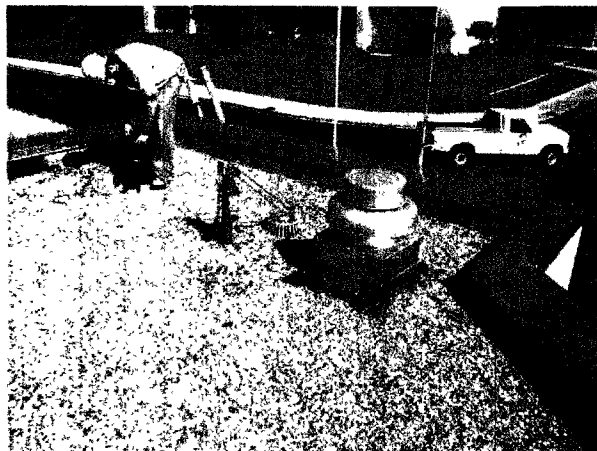
Photo No. 34

The roof of the guard building at the main entrance, looking northwest. Note the pipe inserted into the toilet stack.

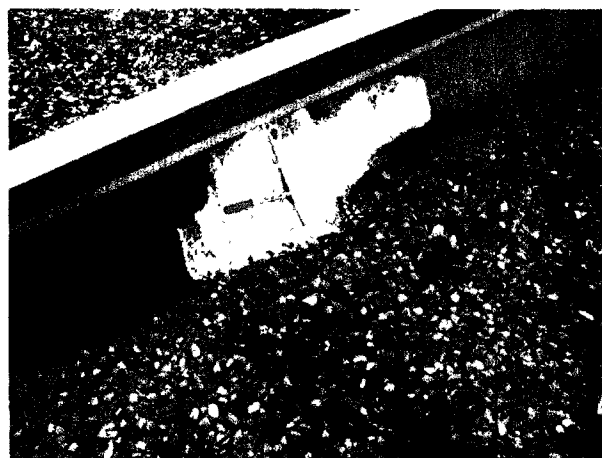
Photo No. 35

A gap in the base flashing in the expansion joint.

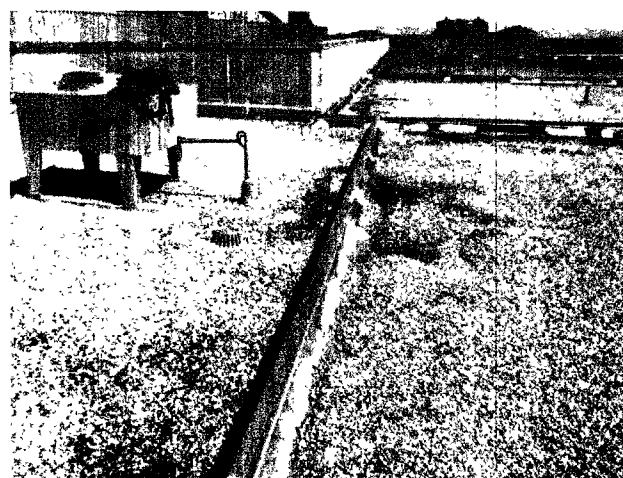
Photo No. 42

The skylight, showing the joint. The dark spots appear to be a growth.
